Rigid HVAC Ducting at Murrieta Public Library

Pilot Program in cooperation with The City of Murrieta, Southern California Edison and Deep Energy Solutions.

Product: CIC Boost

Date: May 2017 – August 2017

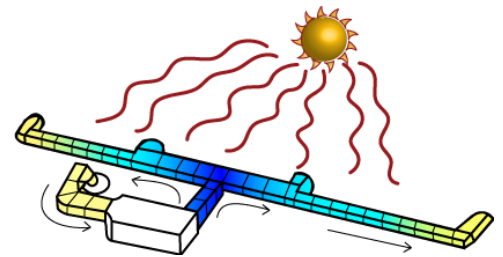
Radiation causes heat from the sun to warm the surface of the ducting. Conduction is the movement of heat from hot side toward the cold side through the walls of the ducting which causes air in the duct to warm up on a hot day. Convection within the duct circulates the air within the duct. The loss of cold air is shown in the diagram to the left.

After the coating was applied the surface temperature of the ducting was reduced up to 69°F combined with the continuous membrane eliminated the loss of cold air.

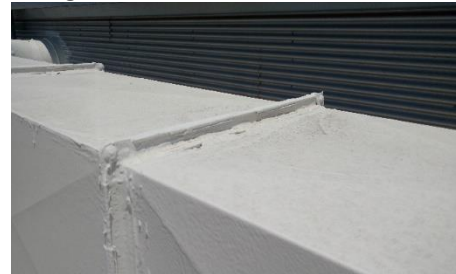
The duct sealant at the joints has failed and there is rust under the sealant that indicates condensation.

An average duct has R-5 insulation inside the duct. This traditional type of insulation has been proven to fail with the moisture of condensation and presents a potential area of mold and mildew within the duct and contributes to corrosion under insulation.

Deep Energy Solutions power washed the ducts with a vinegar solution to remove the loose joint material as well as build-up of dirt.

The application of CIC Boost provided a continuous membrane that sealed the joints along with the entire duct.

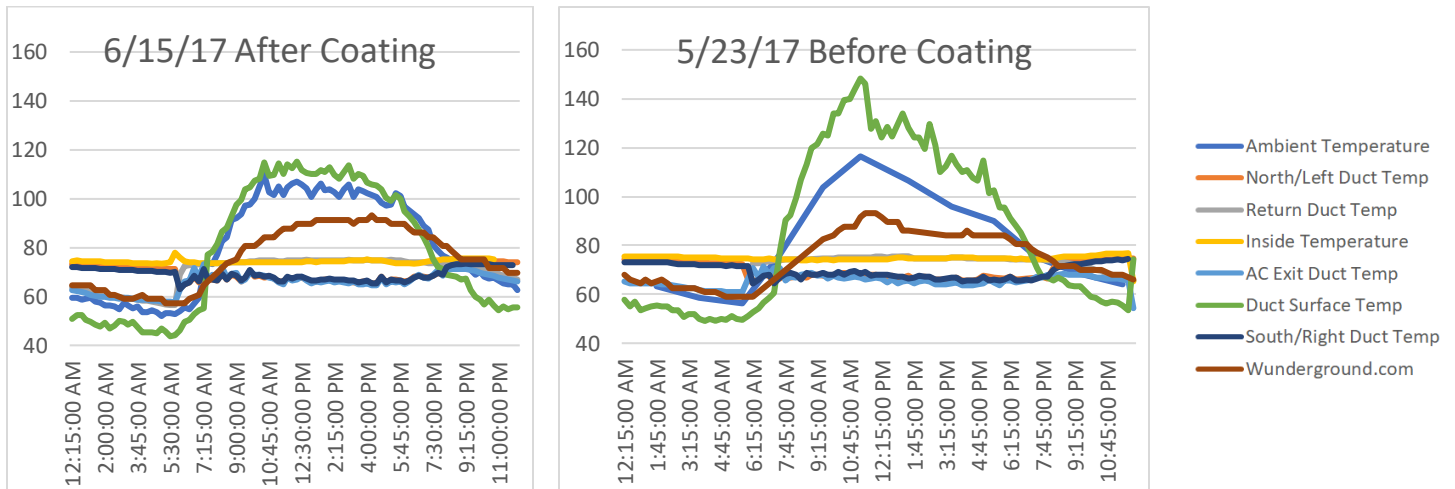
Two Days were selected for comparison, May 23, 2017, which was the hottest day before the coating was applied and June 15, 2017 after the coating was applied. These days were selected because they both had a high temperature of 93.2°F according to wunderground.com

These graphs demonstrate that the coating reduced the surface temperature of the ducting up to 25°F and reduced the heat loss within the ducting by up to 4°F. Additionally, there is a motion sensor that shows that the HVAC unit is cycling on and off after the coating was installed where before the coating was installed the unit came on in the morning and ran all day.

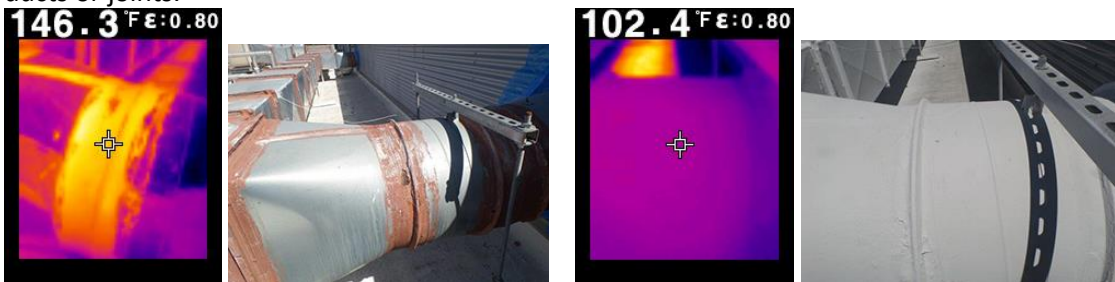
FLIR image and location shots.

The following temperature measurements were recorded with a FLIR TG154 and a location and an image of where the temperature reading was taken for reference. Before Images were taken on 6/3/2017 9:30 AM with an ambient temperature of 77°F and the after images were taken on 6/30/2017 10:30 AM with an ambient temperature of 75°F. This the leaking joints have been sealed and the ducts are not experiencing solar heat loading or conduction through the ducts or joints.
