# Cinderblock Wall at Murrieta Fire Station #1

Pilot Program in cooperation with The City of Murrieta Fire Department and Deep Energy Solutions.

**CIC Heat Block was applied a cinderblock wall to block solar heat loading**

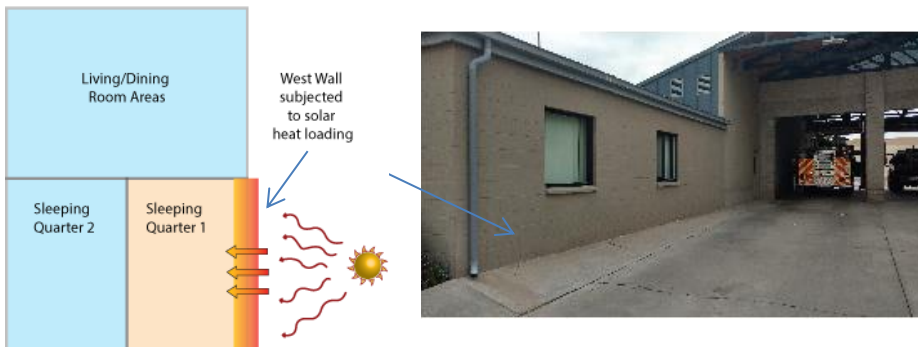
There is one HVAC unit to cool all three of these rooms see diagram below. Solar heat loading on the cinderblock wall is radiating into sleeping quarter 1 raising the temperature of this room. In order to make sleeping quarter 1 more comfortable the AC thermostat is being set to 66°F which is causing sleeping quarter 2 and the Living/Dining Areas to be very cold. Heat would radiate out of this wall through the night making sleeping uncomfortable.

**Goal:** Apply CIC Heat Block to exterior wall of sleeping quarter 1 to block solar heat loading to allow the thermostat to be set higher and make all 3 rooms more comfortable.

**CIC Heat Block** was applied to the west facing wall as shown in the diagrams above on September 12, 2017. The final coating of CIC Heat Block was tinted to match the building. However, the original color of this wall was a lighter color than the building. You can see the lighter color in the back portion of the wall visible in the picture above. On some days the exterior wall measures at hotter temperature than before the coating was applied due to the darker color being a heat sink, but the interior wall was cooler due to the thermal insulating properties of the CIC Heat Block.

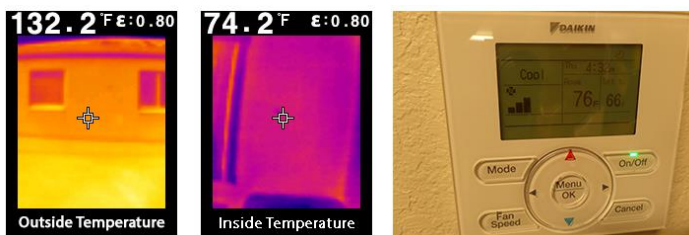
## Before coating with CIC Heat Block

On August 4<sup>th</sup>, 2017 the high temperature according to wunderground.com was 93°F. The exterior surface of the wall measured 132.2 °F with FLIR imaging gun. The interior wall measured 74.2°F. The thermostat was set to 66°F but the interior temperature was 76°F. This is 10°F higher than the setting causing the HVAC unit to run continuously.

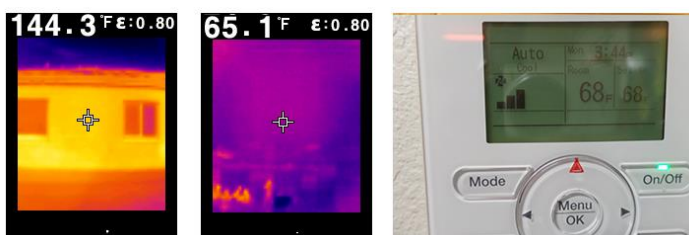
## After applying CIC Heat Block

On October 16<sup>th</sup>, 2017 high temperature according to wunderground.com was 96°F. The exterior surface of the wall measured 144.3 °F with FLIR imaging gun. The interior wall measured 65.1°F. The thermostat was set to 68°F and the interior temperature was 68°F.
