ACS CIC 4.0 was applied to the HVAC ducting that is located full sun subjecting it to solar heat loading

- **Product:** ACS CIC 4.0
- **Date:** 07/21/2016
- **Goals:** Prevent Solar Heat Loading, Bridge Gap at Expansion Joints, and Seal Joints

Details of the Lake Elsinore Unified School District Project

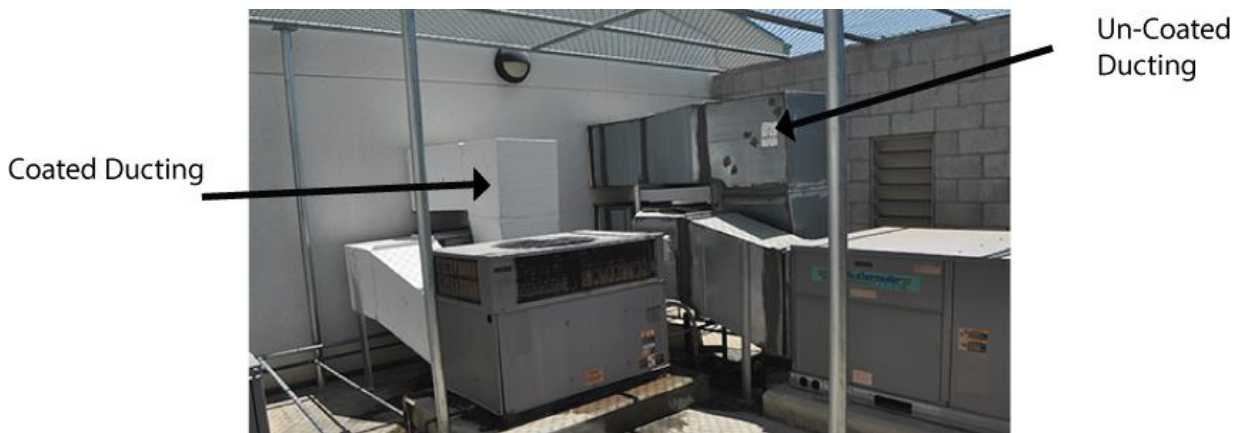
A 30 mil coating of ACS CIC 4.0 was sprayed on to one of the units using the CIC Flex Application Spray Gun.

Temperature was recorded with a FLIR TG155 comparing the temperature of the coated unit with the uncoated unit next to it as shown in the picture above. The readings were taken on 7/21/2016 at 12:00 pm. with an ambient temperature of 103°F.

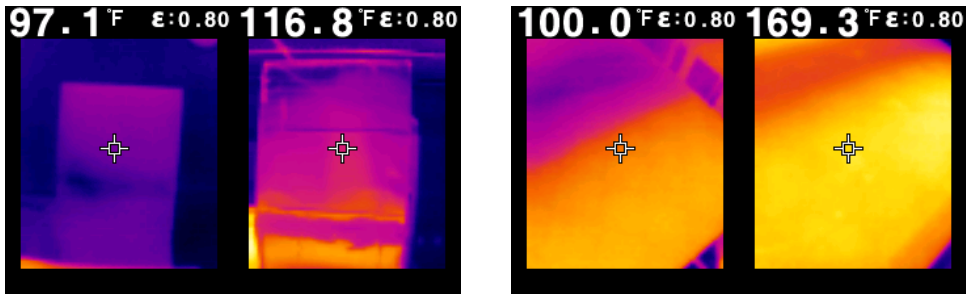
- Front side of the ducting showed a reduction in temperature of 19.7°F
- Top of the ducting – Reduction of 69.3°F

The FLIR image displays hotter areas in orange or yellow the cooler areas are purple to blue with a range in between. The number at the top of the screen is the temperature at the cross hairs. Infrared cameras do not measure surface temperatures, they actually measure the intensity of infrared radiation (radiant energy) being emitted by the surface it is aimed at. These images show energy loss and savings through the metal substrate of the duct.

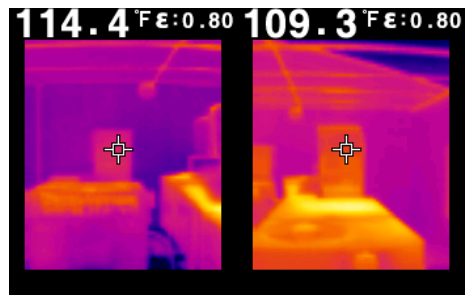
Follow up temperature measurements were taken on 8/2/2016 at 2:00 PM. The ambient temperature was 89°F - Both units were running and in the sun

- Front of the coated ducting measured 5.1°F higher

This is an example of conduction. The sun does not directly shine on this surface. The cold air within the unsprayed duct was passing through the metal and lowering the temperature reading demonstrating a loss of cold air. The coated ducting was keeping the cold air within the duct resulting in a higher outside reading.

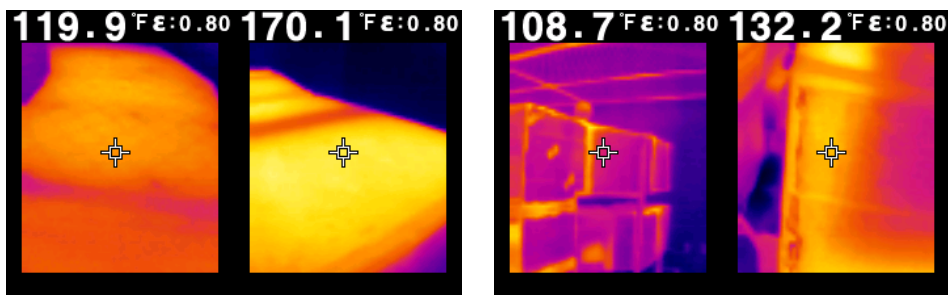
- The top of the units were both in full sun. The measurements demonstrated a 50.2°F reduction.
- Ducting attached to HVAC Unit showed a reduction of 23.5°F
