LEUSD HVAC Project

CIC Boost was applied to the HVAC ducting that is located full sun subjecting it to solar heat loading

- **Product:** CIC Boost
- **Date:** 07/21/2016
- **Goals:** Prevent Solar Heat Loading, Bridge Gap at Expansion Joints, and Seal Joints

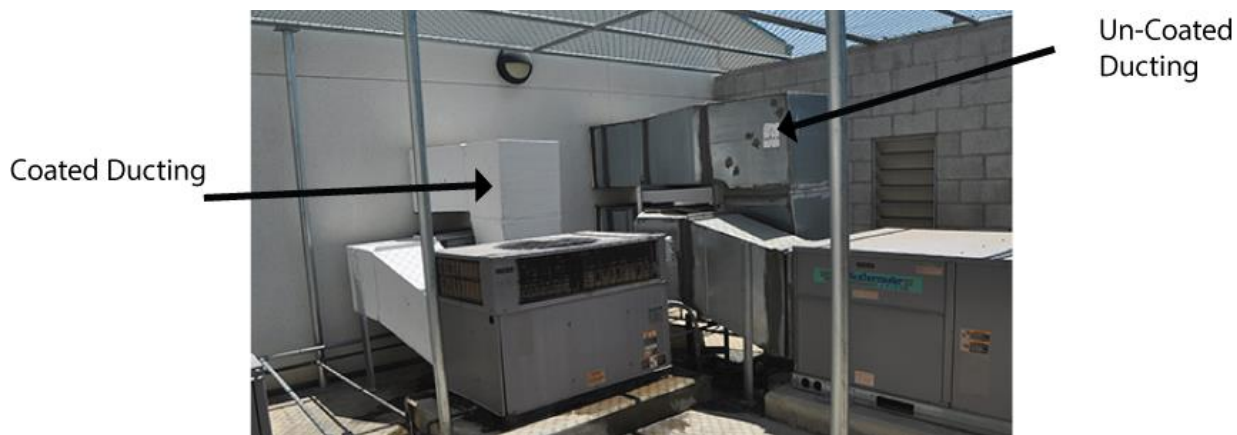
A 30 mil coating of CIC Boost was sprayed on to one of the units using the CIC Flex Application Spray Gun.

Temperature was recorded with a FLIR TG155 comparing the temperature of the coated unit with the uncoated unit next to it as shown in the picture above. The readings were taken on 7/21/2016 at 12:00 pm. with an ambient temperature of 103°F.

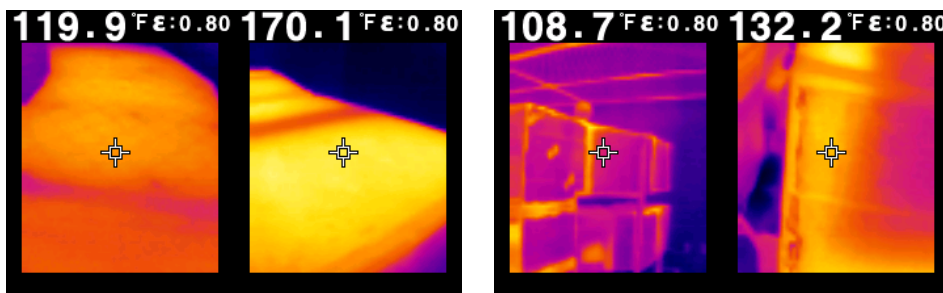
- The top of the units were both in full sun. The measurements demonstrated a 50.2°F reduction.
- Ducting attached to HVAC Unit showed a reduction of 23.5°F
