CIC Heat Block Reduces Riverside Building Temperature by 20°F

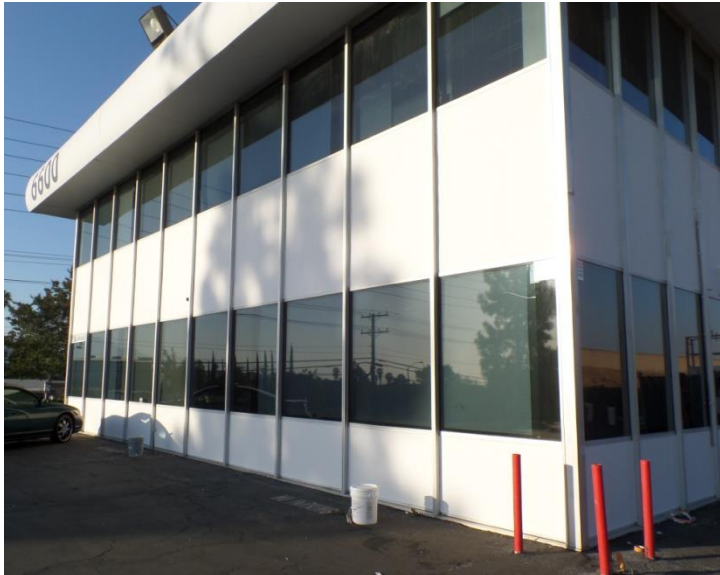
Test panels coated with Ceramic Insulation Coating measured 123°F on uncoated area and 103°F on coated area at 11:00AM based on measurements using a FLIR TG165 Imaging IR Thermometer. Ambient outside temperature was 91.1°F. The 123°F on the exposed outside surfaces demonstrates the effect of solar heat loading and the 20°F reduction clearly demonstrates CIC Heat Block's ability to also reduce interior heat loads. Reducing outside wall temperature lowers inside wall temperature and air conditioning costs.

Metal panels on two exterior walls of this Riverside, CA office building were coated with Ceramic Insulation Coating (CIC) Heat Block in May, 2015. The building has metal panels between the windows and very high AC costs during hot months. Before applying CIC coating, AC started at 8:30AM and ran continuously until shut off at 5:00PM. After coating with CIC, AC doesn't start operating until noon and runs intermittently during the afternoon.
