Rigid HVAC Ducting at Murrieta Public Library

Pilot Program in cooperation with The City of Murrieta, Southern California Edison and Deep Energy Solutions.

ACS CIC 4.0 was applied to the HVAC ducting Reduce Solar Heat Loading, Seal Duct Joints and Eliminate Rust and Corrosion

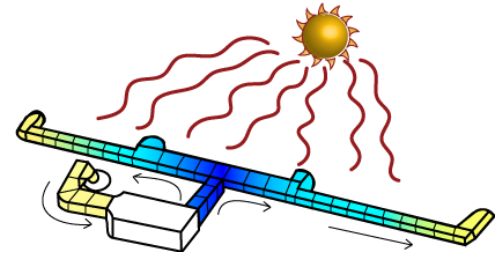
Radiation causes heat from the sun to warm the surface of the ducting. Conduction is the movement of heat from hot side toward the cold side through the walls of the ducting which causes air in the duct to warm up on a hot day. Convection within the duct circulates the air within the duct. The loss of cold air is shown in the diagram to the left.

After the coating was applied the surface temperature of the ducting was reduced up to 69°F combined with the continuous membrane eliminated the loss of cold air.

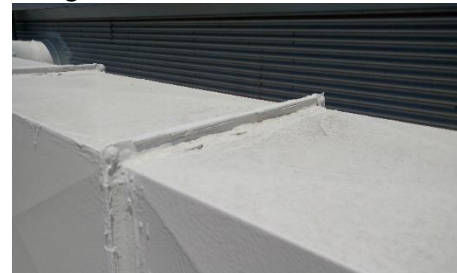
The duct sealant at the joints has failed and there is rust under the sealant that indicates condensation.

Deep Energy Solutions power washed the ducts with a vinegar solution to remove the loose joint material as well as build-up of dirt.

The application of ACS CIC 4.0 provided a continuous membrane that sealed the joints along with the entire duct.

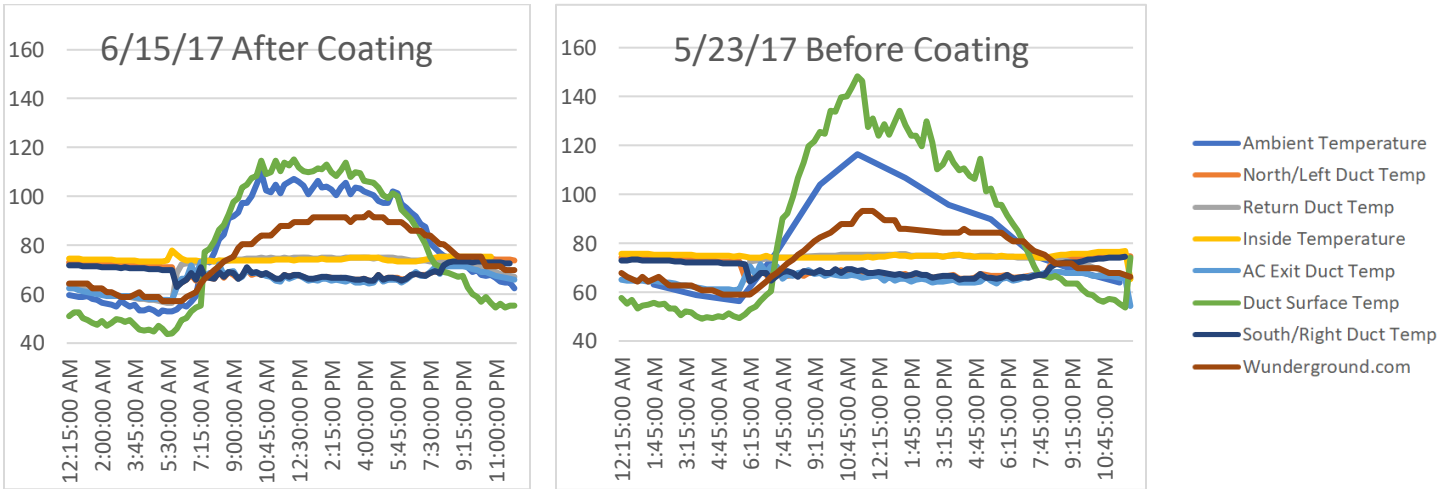
These graphs demonstrate that the coating reduced the surface temperature of the ducting up to 25°F and reduced the heat loss within the ducting by up to 4°F. Additionally, there is a motion sensor that shows that the HVAC unit is cycling on and off after the coating was installed where before the coating was installed the unit came on in the morning and ran all day.

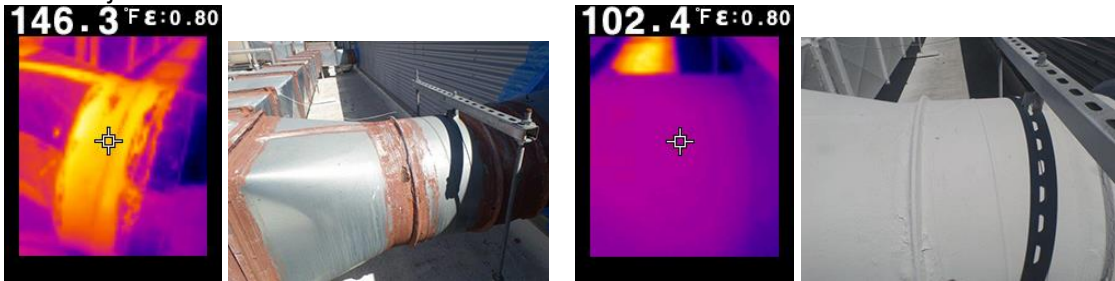
FLIR image and location shots.

The following temperature measurements were recorded with a FLIR TG154 and a location and an image of where the temperature reading was taken for reference. Before Images were taken on 6/3/2017 9:30 AM with an ambient temperature of 77°F and the after images were taken on 6/30/2017 10:30 AM with an ambient temperature of 75°F. This the leaking joints have been sealed and the ducts are not experiencing solar heat loading or conduction through the ducts or joints.
