Cinderblock Wall at Murrieta Fire Station #1

Pilot Program in cooperation with The City of Murrieta Fire Department and Deep Energy Solutions.

ACS CIC 4.0 was applied a cinderblock wall to block solar heat loading

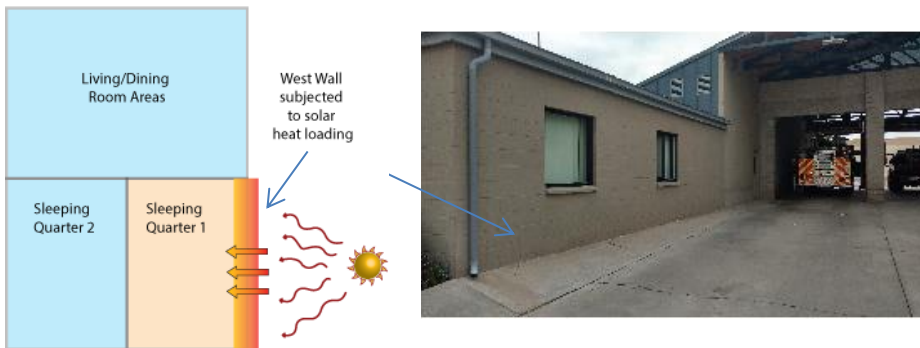
There is one HVAC unit to cool all three of these rooms see diagram below. Solar heat loading on the cinderblock wall is radiating into sleeping quarter 1 raising the temperature of this room. In order to make sleeping quarter 1 more comfortable the AC thermostat is being set to 66°F which is causing sleeping quarter 2 and the Living/Dining Areas to be very cold. Heat would radiate out of this wall through the night making sleeping uncomfortable.

Goal: Apply ACS CIC 4.0 to exterior wall of sleeping quarter 1 to block solar heat loading to allow the thermostat to be set higher and make all 3 rooms more comfortable.

ACS CIC 4.0 was applied to the west facing wall as shown in the diagrams above on September 12, 2017. The final coating of ACS CIC 4.0 was tinted to match the building. However, the original color of this wall was a lighter color than the building. You can see the lighter color in the back portion of the wall visible in the picture above. On some days the exterior wall measures at hotter temperature than before the coating was applied due to the darker color being a heat sink, but the interior wall was cooler due to the thermal insulating properties of the ACS CIC 4.0.
